Eurolithos case study

Built heritage of Nicosia, Cyprus: the use of calcarenite as built stone from antiquity to recent times

Thematic focus: Stone and built heritage

Responsible partner: Geological Survey Department

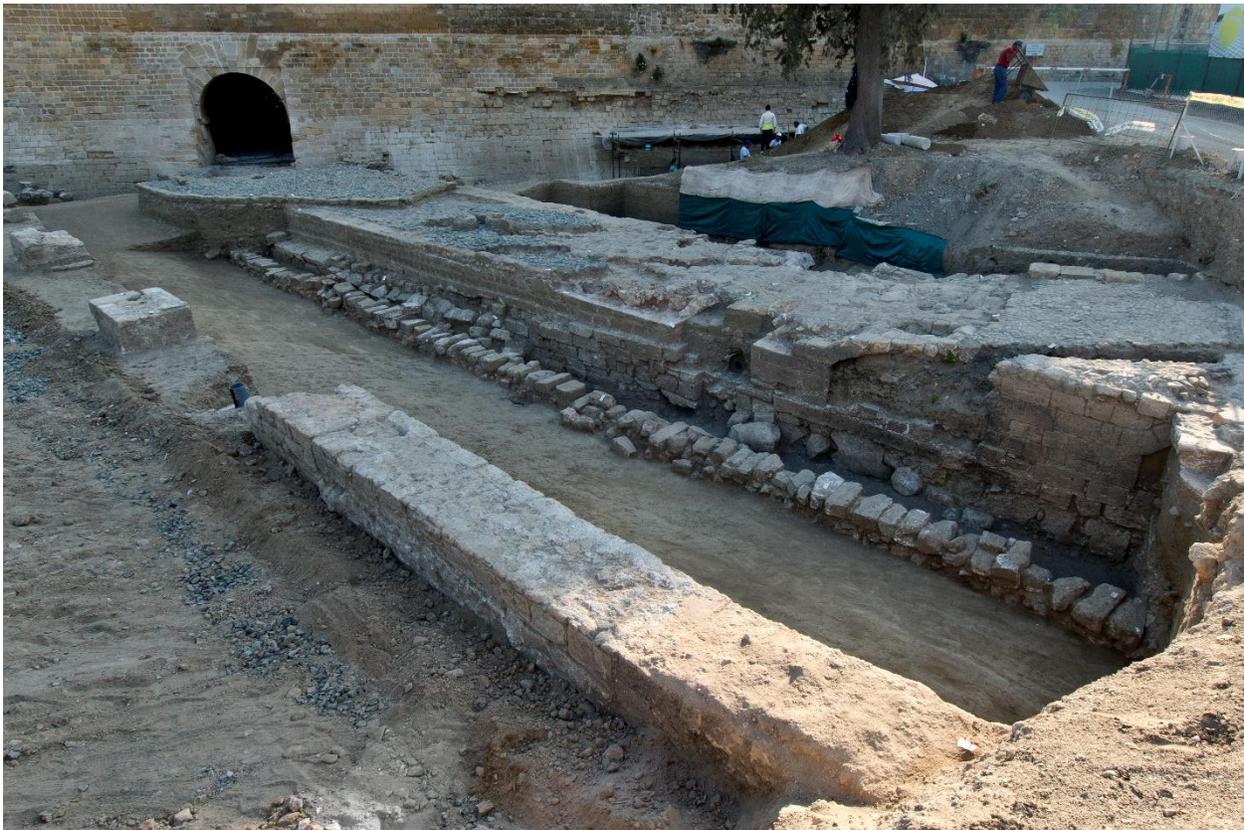
Fig. 1: Conservation works of the external face of the Walls at the Pafos Gate after excavation

According to the Antiquities Law and its amendments, antiquity is any object, movable or part of immovable property which is a work of architecture, sculpture, graphic art, painting, or generally any form of art which has through human effort been produced, sculptured, inscribed, or painted or generally made in Cyprus and they are older than 100 years old. In addition, the Council of Ministers, upon the request of the Director of the Department of Antiquities, may proceed to the declaration of any object, building or site that is considered to be of public interest by reason of historic, architectural, traditional, artistic or archaeological interest as an Ancient Monument. Buildings with traditional architecture which are listed as cultural heritage are protected by the Town Planning and Housing Law. The conservation of any archaeological sites is completely controlled by the Department of Antiquities through the implementation of its law. The conservation works are systematically supervised by its experienced personnel and its experienced in traditional building technics craftsmen. The conservation of the part of Venetian walls of Nicosia that is under the authority of the Antiquities Department is systematic. as it can be seen in Figure 1 shows an example of such conservation works.

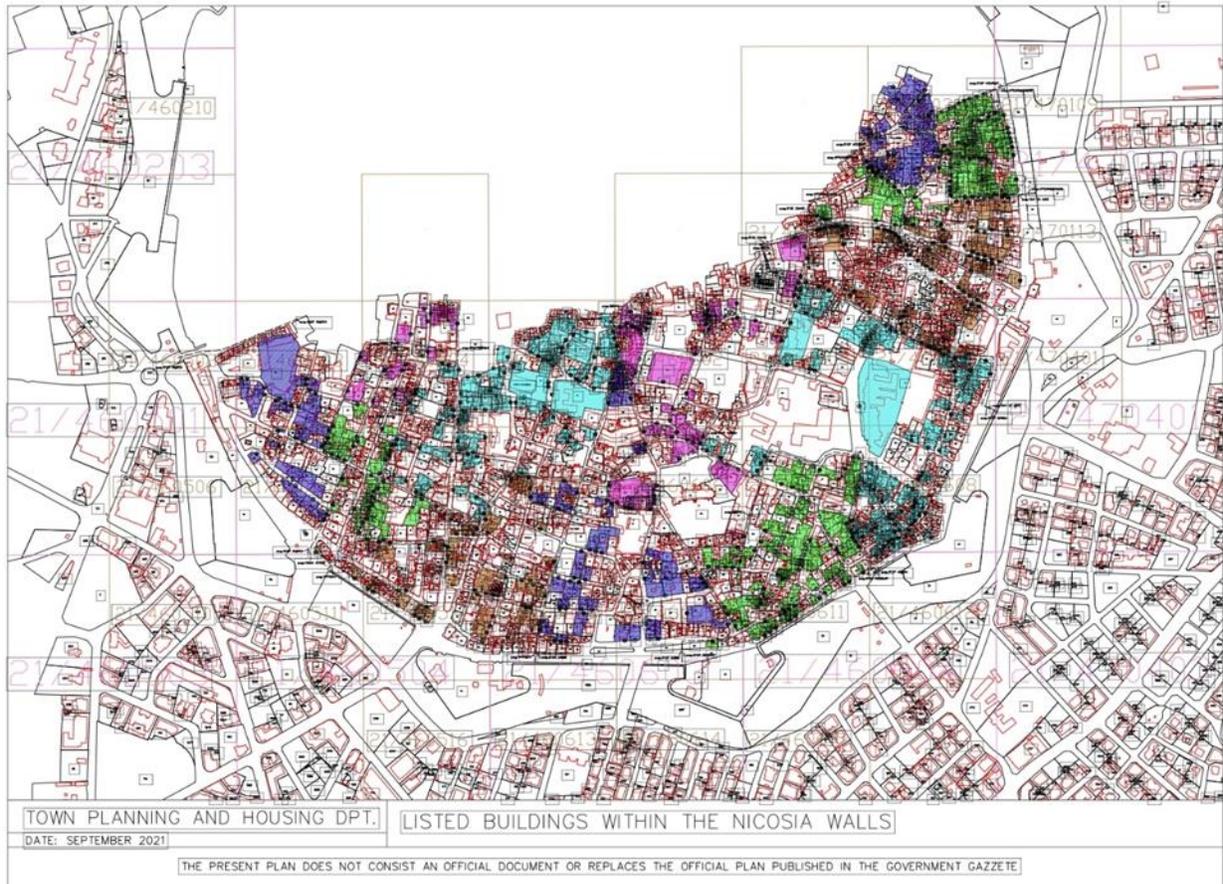
Fig. 2: A drawing of the listed buildings within the Nicosia's walls

Regarding the conservation or maintenance of listed buildings, the Department of Town Planning and Housing is the competent authority. The Department of Town Planning and Housing, has developed series of plans on which the listed buildings are documented. An example of such plans is shown in figure 2 which displays the listed buildings within the Nicosia's walls in solid colors. The different colors indicate the parishes that exist inside the walls of Nicosia.

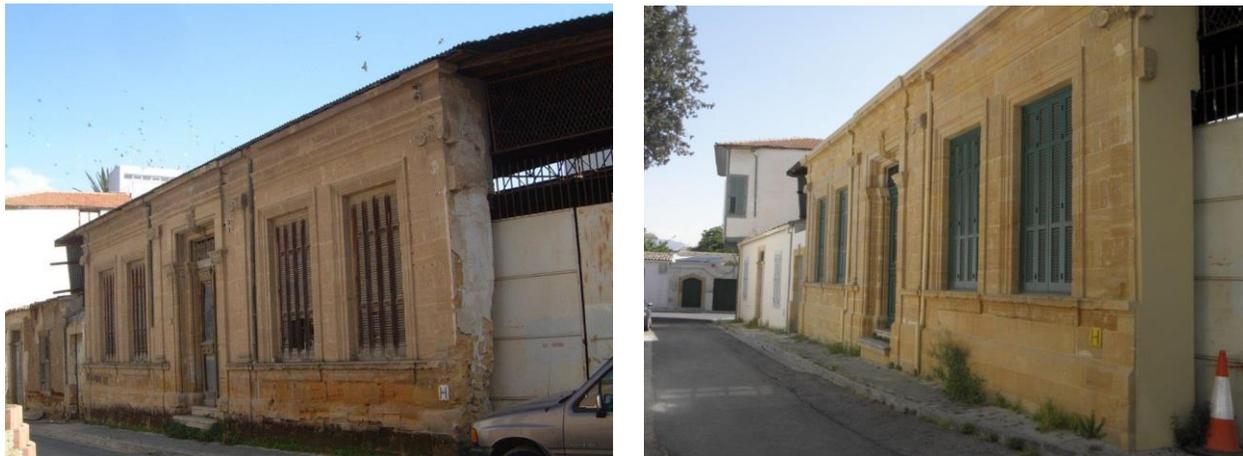
Fig. 3: Part of a neighborhood in the area of Takt-El-Kale, before and after the reconstruction of the buildings

Besides the governmental Departments dealing with the conservation of the cultural heritage, the Municipalities can equally play important role the conservation of their built heritage. They can take advantage of financial incentives both from the Government and European Union. An example are the bi-communal priority projects within the walled city such as the Chrysaliniotissa Revitalization, the Conservation of the medieval Silihtar Aqueduct, Revitalisation of the Omerye Area etc. The aim of these projects is the intervention and conservation of selected homogeneous areas in the historic center of Nicosia, based on the areas' architectural character, social merits and economic viability. Another example are the co-funded projects by the Structural Funds of the European Union, the State Budget and the Municipality. Such a project is the reconstruction of the area of Takt-El-Kale, within the walls of Nicosia. Figure 3 shows a part of a neighborhood in the area of Takt-El-Kale, before and after the reconstruction of the buildings.

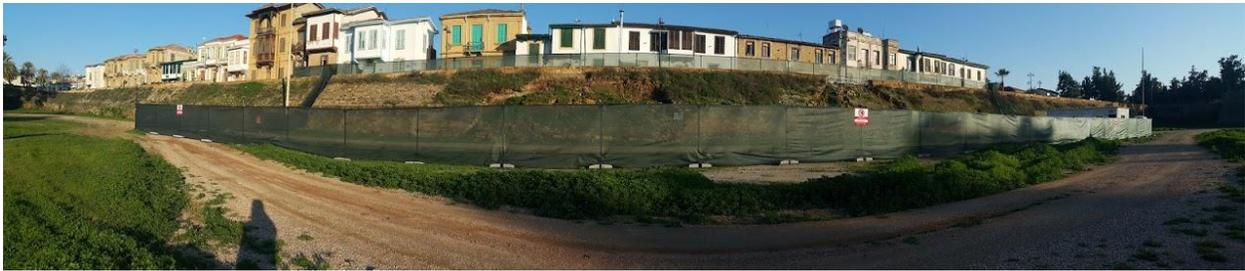
Fig. 4: Panoramic view of the collapsed part of the Venetian Walls

Listed buildings are often left intentionally uninhabited without any basic maintenance until **it** sometimes they totally collapse. Some owners knowing that they cannot obtain a permit to demolish a listed building employ this practice especially if they want to build a commercial block or a block of apartments in their plot. In cases of monuments as well, the lack of maintenance or conservation can lead to catastrophic events. Such an example is the collapse of part of the Nicosia's Venetian Walls in the areas where the **R**epublic of Cyprus has not effective control. It should be pointed out that this case does not concern a private building, but an Ancient Monument and in fact the trademark of Nicosia. The negligence belongs to the Turk-Cypriot Community, not to an individual. Figure 4 shows the collapse part of the Venetian wall whereas the figure 5 shows the temporary measures taken to prevent further collapse of the walls. The restoration and conservation of this part of the walls has been undertaken by the Bicommunal Technical Committee for Cultural Heritage. For such landmarks related with the history of Nicosia, the preventive maintenance would be preferable.

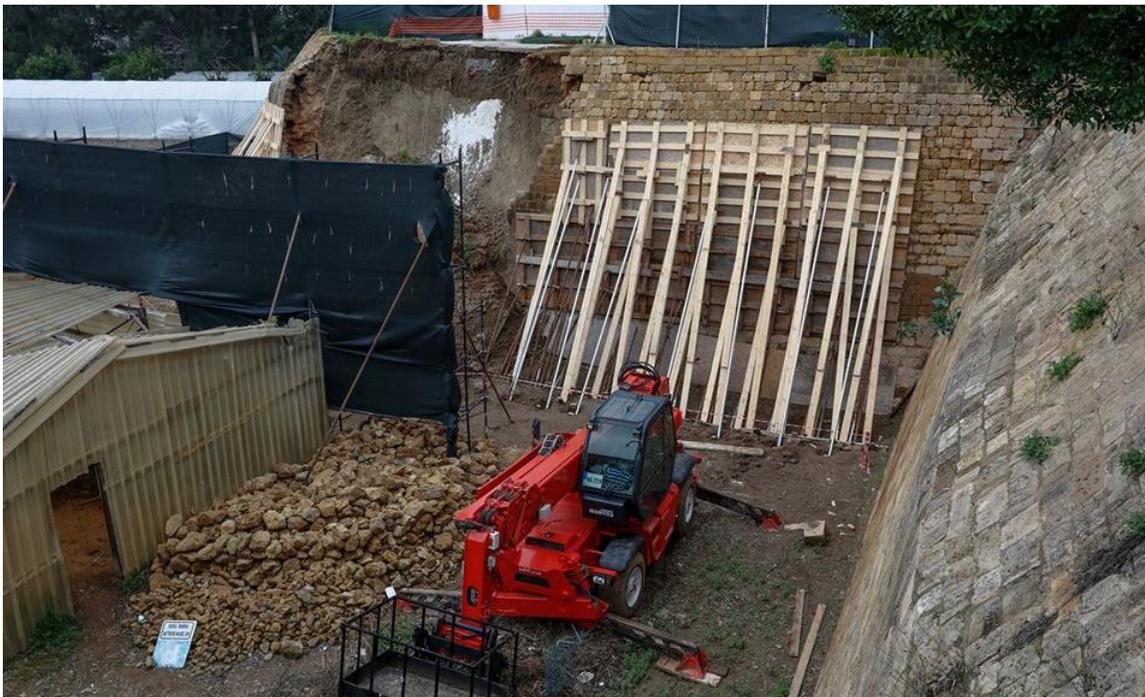
Fig. 5: Temporary measures taken to prevent further collapse of the Venetian Walls

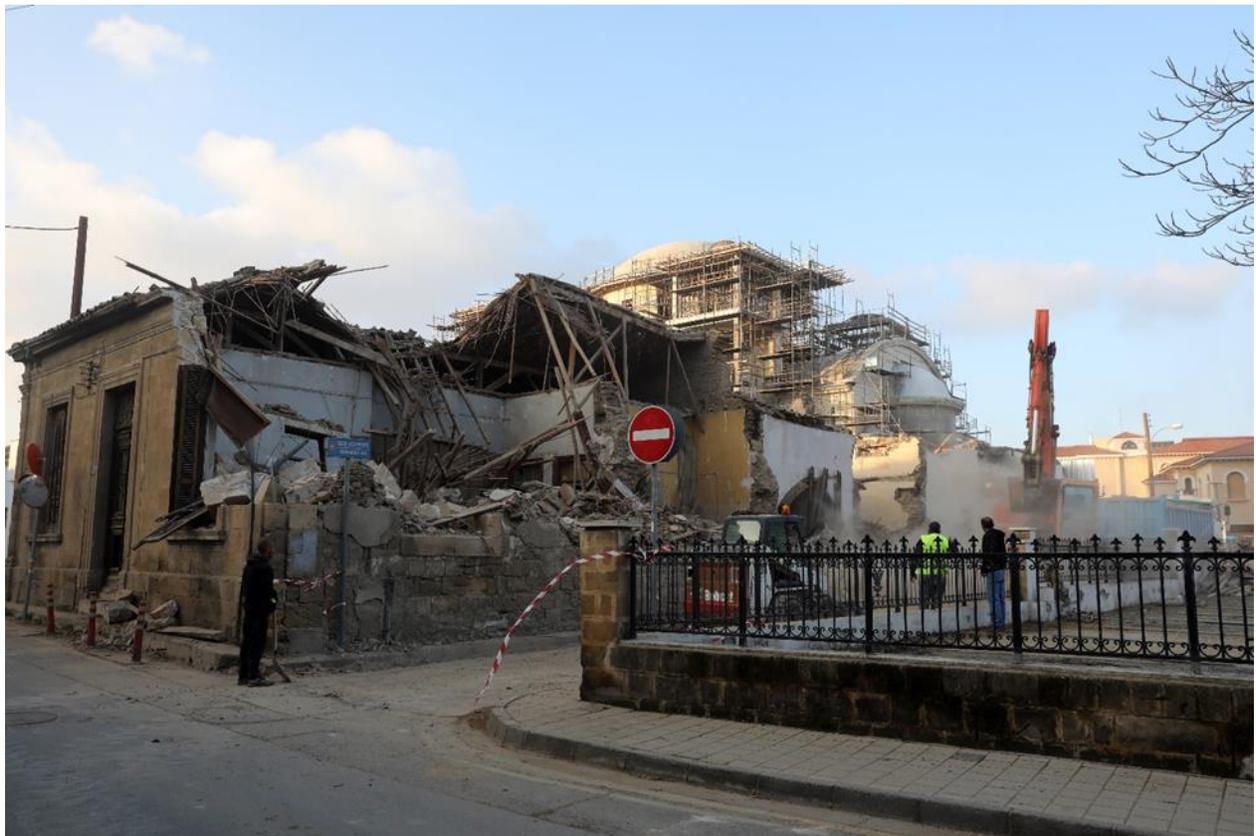
Fig. 6: A listed building during the attempt to demolish it

A couple of months ago, such an incident occurred. A demolition team started the pulling down of a listed building, without the owner to obtain the necessary licenses. In this case there was immediate reaction of the non-governmental organizations and the general public uploading stories and pictures in the social media. This caused the effective intervention of the competent authorities which forced the demolition team to stop and leave the site. Eventually, the Municipality of Nicosia came to an agreement with the owner to reconstruct it. Figure 6 shows the condition of the listed building during the attempt to demolish it.

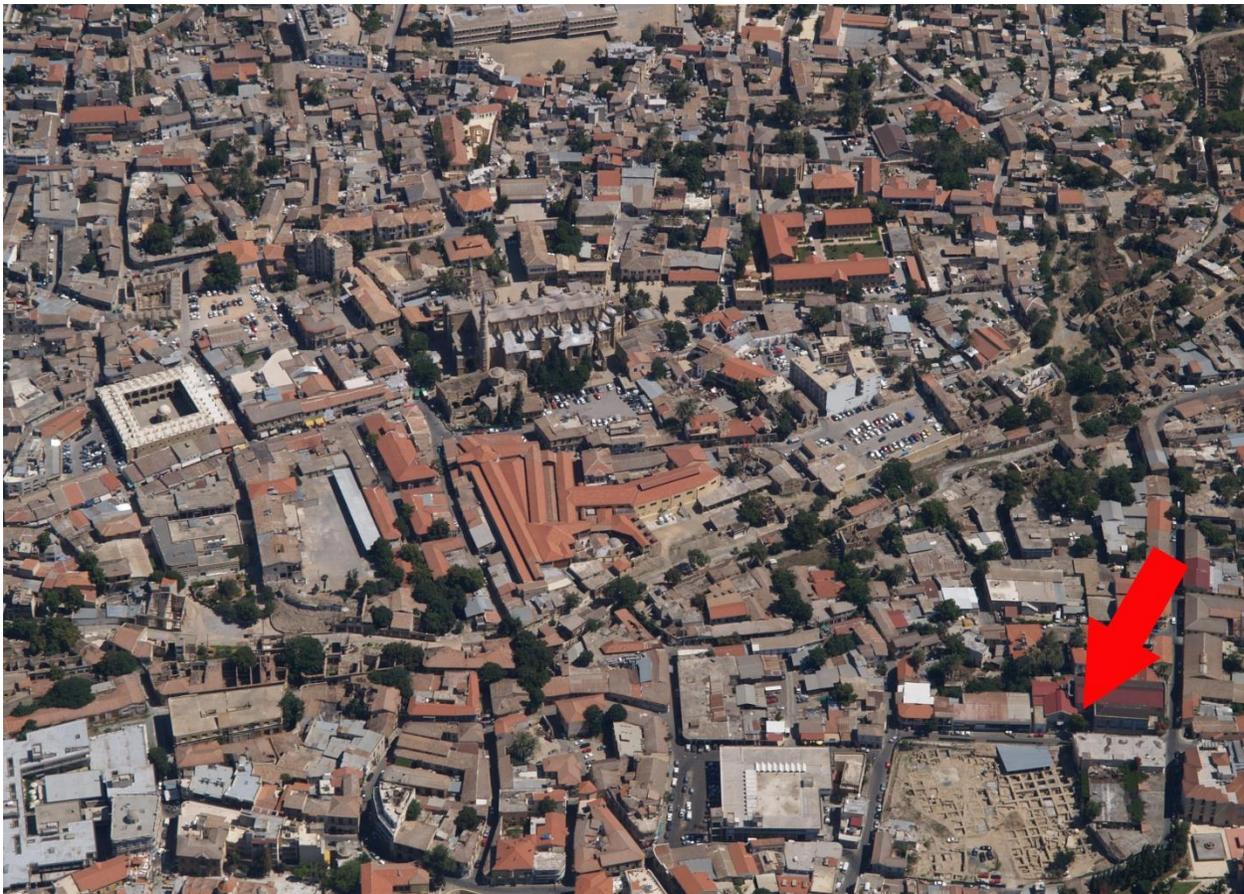
Fig. 7: An aerial of the center of the old town of Nicosia.

The Palaion Demarcheion (Old Town Hall) archaeological site is located in the heart of Nicosia's walled old town. According to the Department of Antiquities, the first excavation period at this site started in June 2002 and the excavation continued until 2008. The excavations have revealed important information concerning the capital's history from the 11th century A.D. up until the 19th century A.D. In other words, from the middle Byzantine period until the British colonial period. More specifically, a large section of the Byzantine and Medieval town has been excavated, including two churches, the remains of monumental buildings, workshops, roads, wells etc. There is also evidence for human presence during the Middle Bronze Age period. The large number of moveable finds, mainly dating to the Byzantine and the Medieval period, present a rather clear picture of everyday life in the capital but also of Nicosia's commercial relations with other parts of the island and abroad. During our site visit, with the permission of the site Director, we noticed evidences indicating the repeated reuse of the building stones. The majority of the building stones were of calcarenite. The red arrow on the figure 7 indicates the archaeological site of the Palaion Demarcheion in Nicosia.

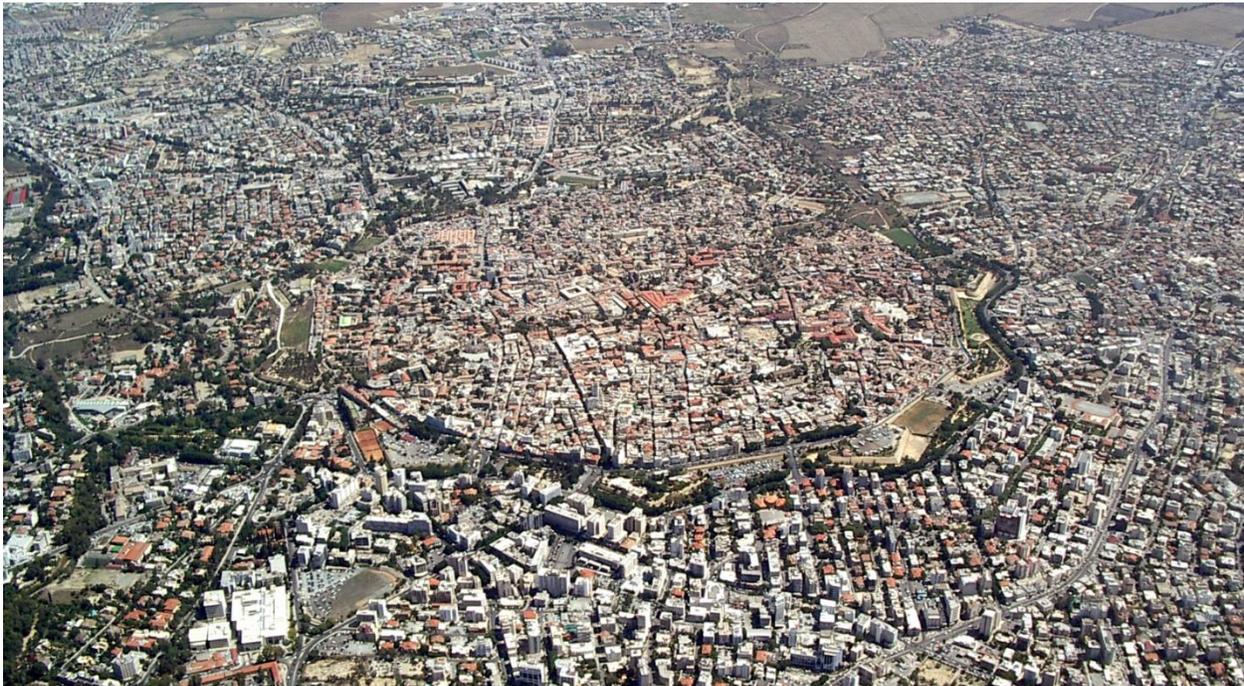
Fig. 9: An aerial photograph of the old town Nicosia and its Venetian walls.

The Venetian walls of Nicosia have a circular shape, with a circumference of 5 km (3 miles). The walls contain eleven pentagonal bastions resembling to the shape of a heart, similar to the bastions of Palmanova in Northeast Italy. The bastions are named after eleven families of the Italian aristocracy of the town, who donated for the construction of the walls. Figure 9 shows the Venetian Walls as they are today.

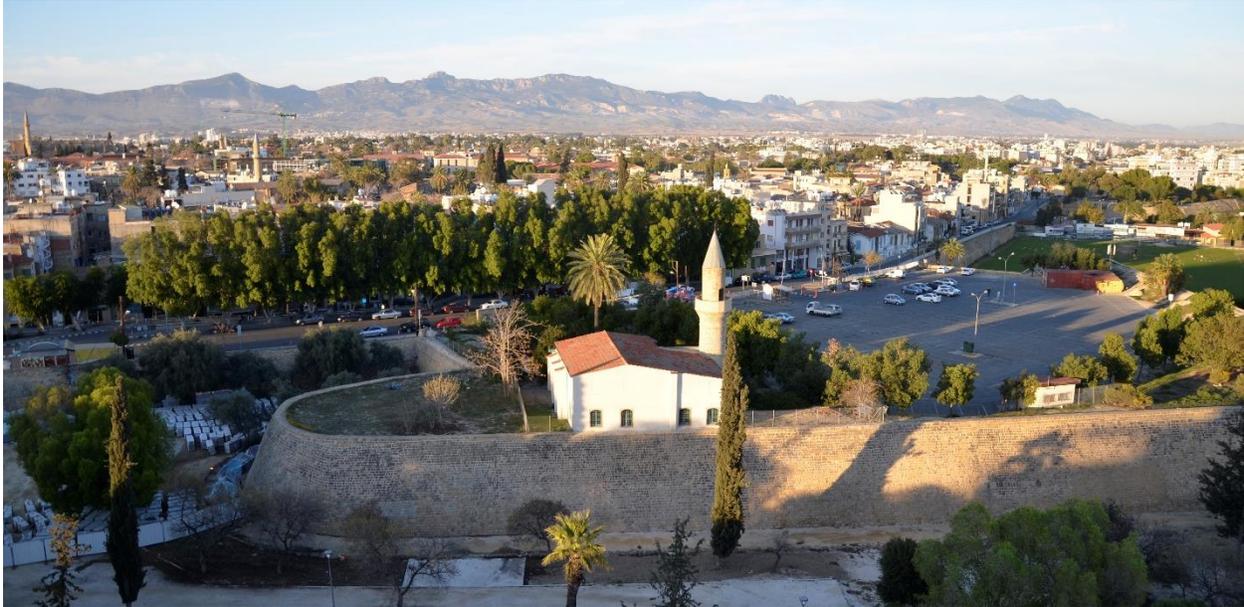
In figure 10, the shape of a bastion that resembles with the shape of a heart and part of the of the wall can be seen. The condition of the walls in the part of Nicosia where the Republic of Cyprus has effective control is very good due to their systematic maintenance by the Department of Antiquities.

Fig. 10: An aerial photograph of the old town Nicosia and its Venetian walls.

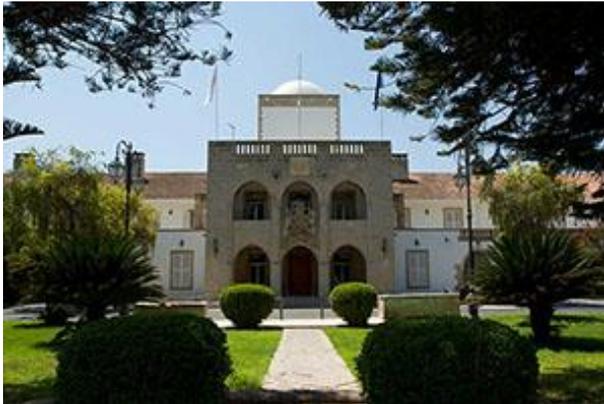
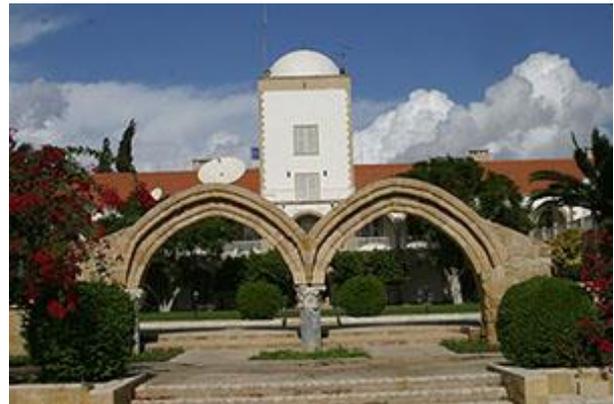
Fig. 11: The front and back view of the Presidential Palace in Nicosia.

Byzantine and Gothic elements, but also a few Turkish ones, compose the architecture of the building. For the general construction of the building, calcarenite (pouropetra) was used from quarries Gerolakkos for its light gray-yellow color, hardness and durability.

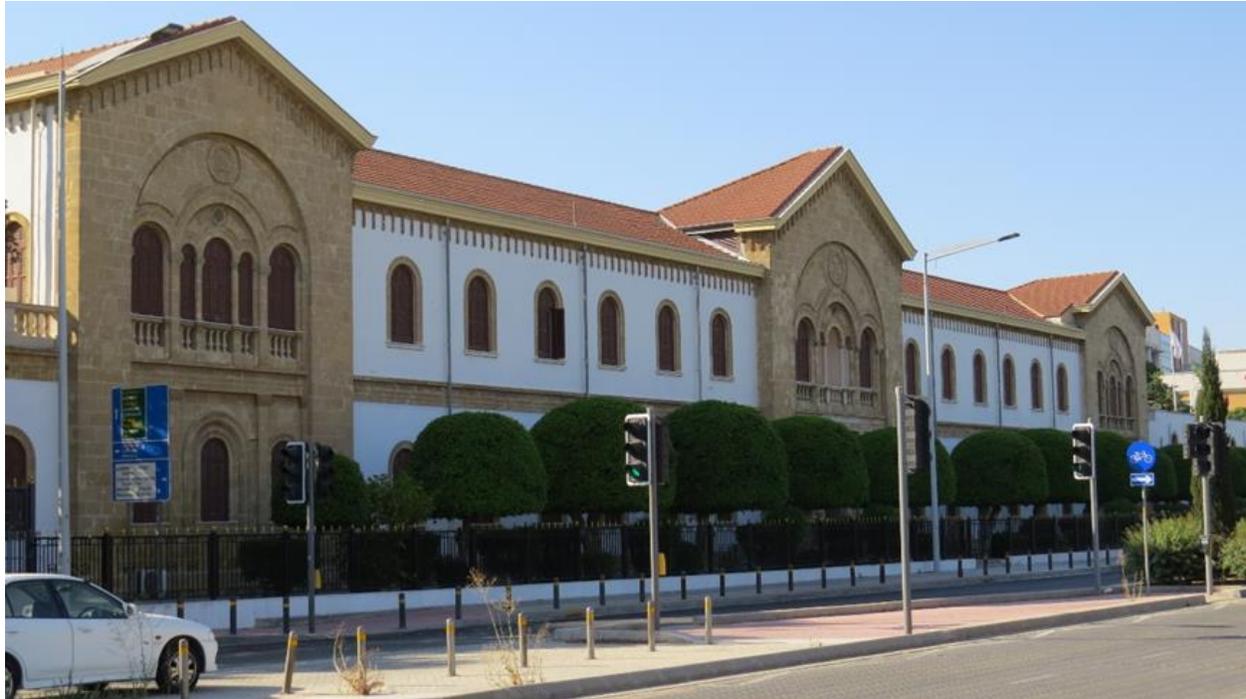
Fig. 12: The front view of the Metochi of the Kykkos Monastery.

The exact foundation of the Metochi of the Kykkos Monastery it is not precisely historically documented. The development of the Metochi to the form that we see it today started in the 19th century. One of its first works was the construction of the new church of Agios Prokopios, which, according to an inscription on the outer west wall, was completed in 1861. Extensive renovation works carried and were completed in 1922.

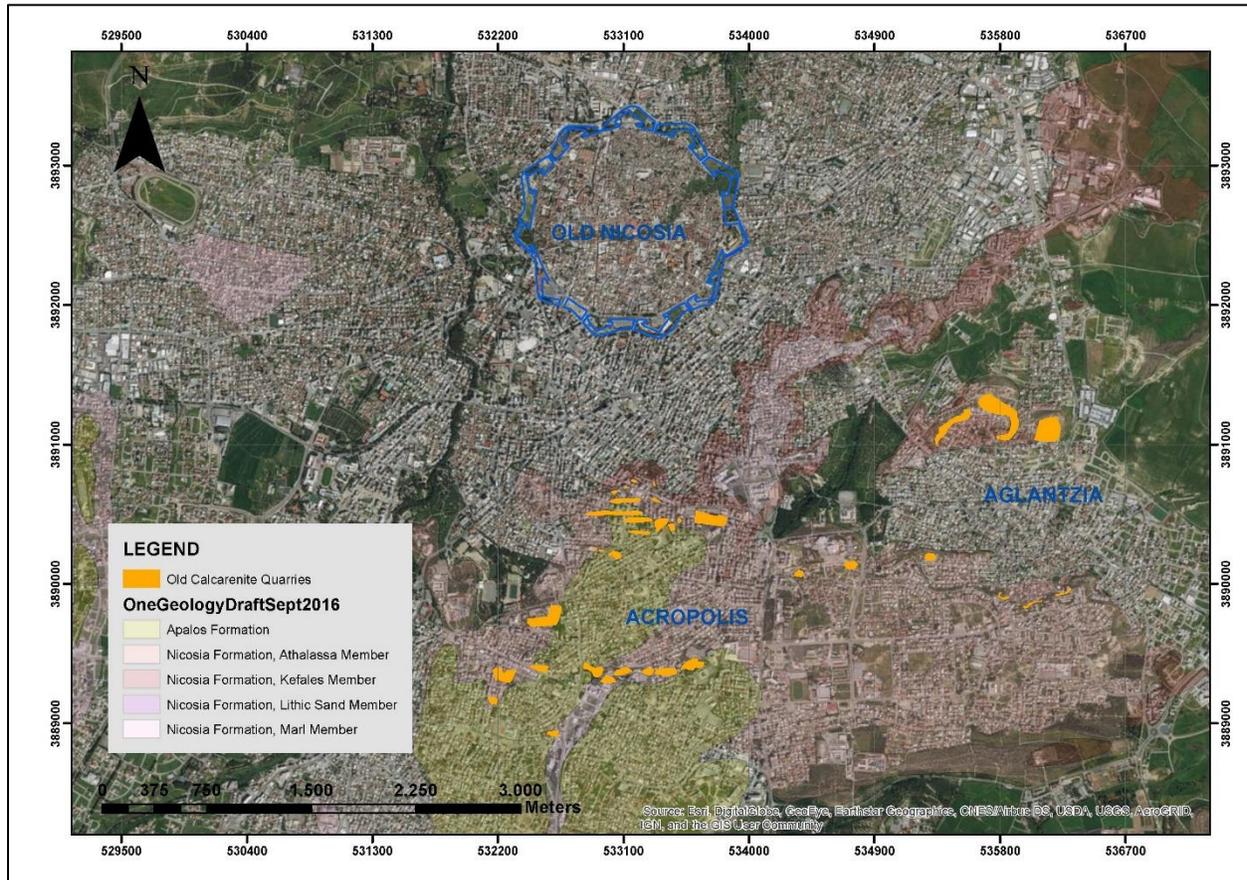
Fig. 13: Satellite image of broader area of Nicosia. The yellow polygons are the mapped underground calcarenite quarries.

Figure 13 shows Satellite image of broader area of Nicosia with the geological units of Nicosia. The yellow polygons show the mapped calcarenite quarries in Nicosia.

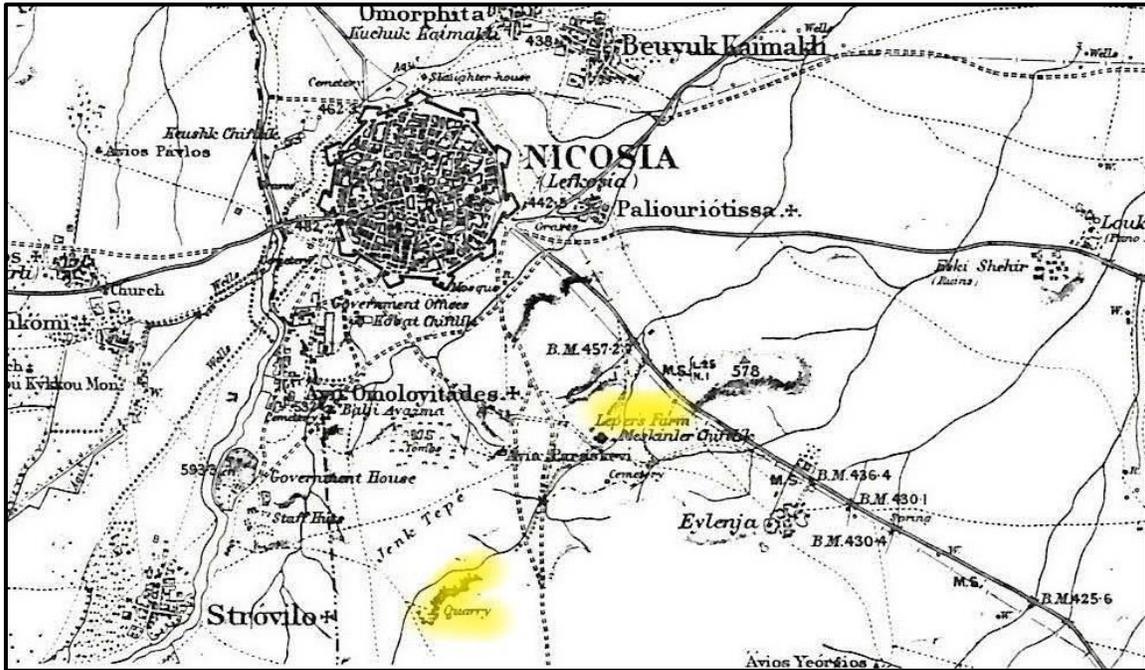
Fig. 14: Adaptation from the Kitchener’s map of Cyprus showing the broader area of Nicosia indicating locations with quarrying of calcarenite.

Considering the long history of the building heritage of Nicosia and the extensive use of calcarenite since antiquity, organized quarrying in the surrounding area must have existed at least since medieval times. Based on the topography of the quarries that we know were operating during the last century, we can infer that the extraction initially was done in open cast quarries and when they formed cliffs with considerable inclination were formed, underground quarrying was undertaken. Under the British administration H.H. Kitchener started in 1882 a Survey of Cyprus, which resulted in the publishing of a detailed map of Cyprus in 1885. Figure 14 shows detail of that map of the broader area of Nicosia, where the two areas highlighted with yellow indicate the quarrying sites near Nicosia. The first one, the Lepers Farm, based on historic references, was an area of older quarries that hosted at that time lepers. The second one which is referred to as quarry is located in Acropolis. Based on the symbology of the map we can deduce that part of the quarry was open cast. Based on further evidences provided from mapping the polygons shown in figure 13, there was extensive underground quarrying at the time. Based on surveys carried out by the Geological Survey Department such underground quarries are located in the areas of

the city of Nicosia and especially in Aglantzia, Agia Paraskevi, Dasoupoli, Acropolis and west of Nicosia in Mammari and Gerolakkos villages.

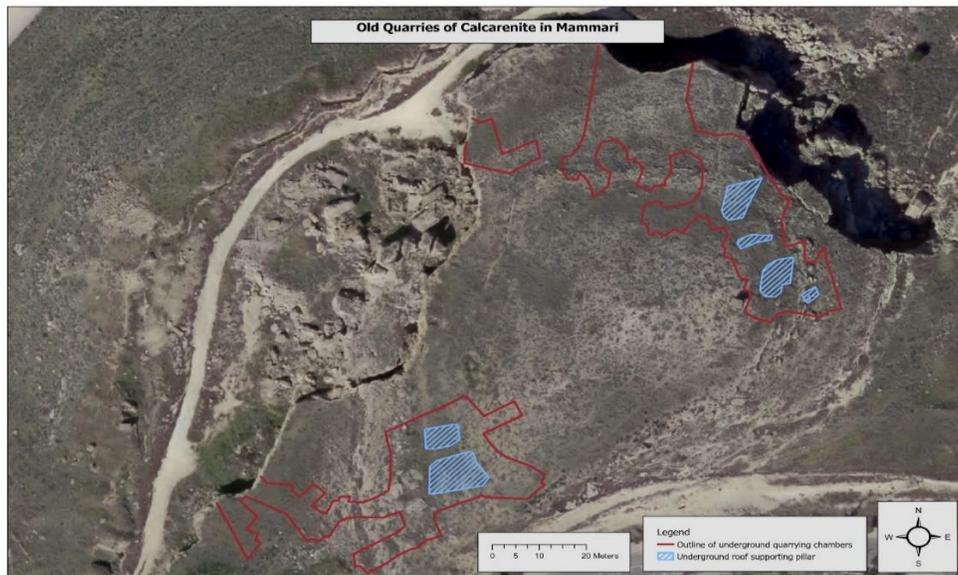
Fig. 15: Satellite image showing the underground calcarenite quarries in Mammari village.

The underground quarries in Mammari were mapped by the Geological Survey Department and were geotechnically evaluated.

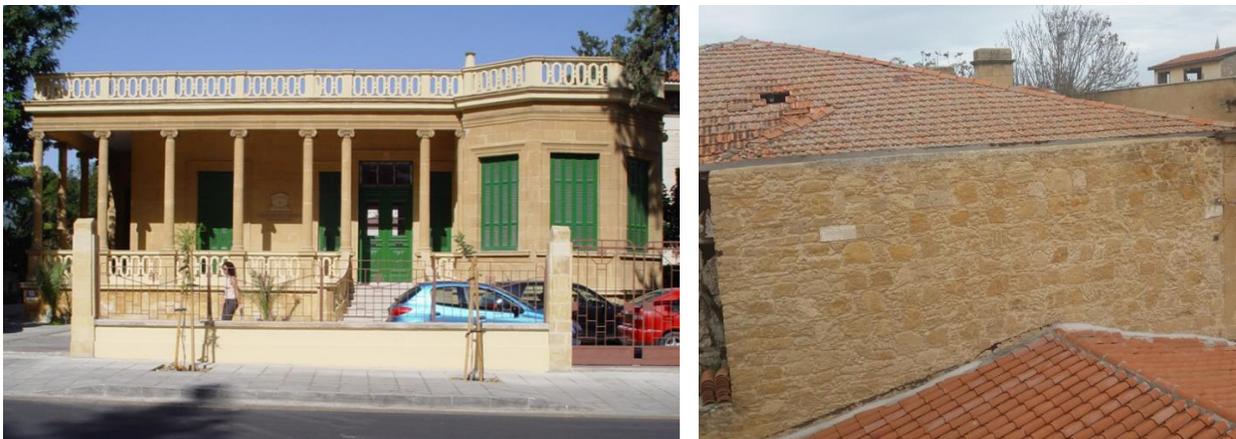
Fig. 16: On the left picture a listed house built exclusively with dimensional and ornamental stone. On the right the walls are built with irregular shape and size pieces of calcarenite.

The use of the above products is shown in figure 16. The sand was used in mortars. This indicates that the quarry men were utilizing the maximum possible use of calcarenite, implementing principles of the circular economy as we understand it today.

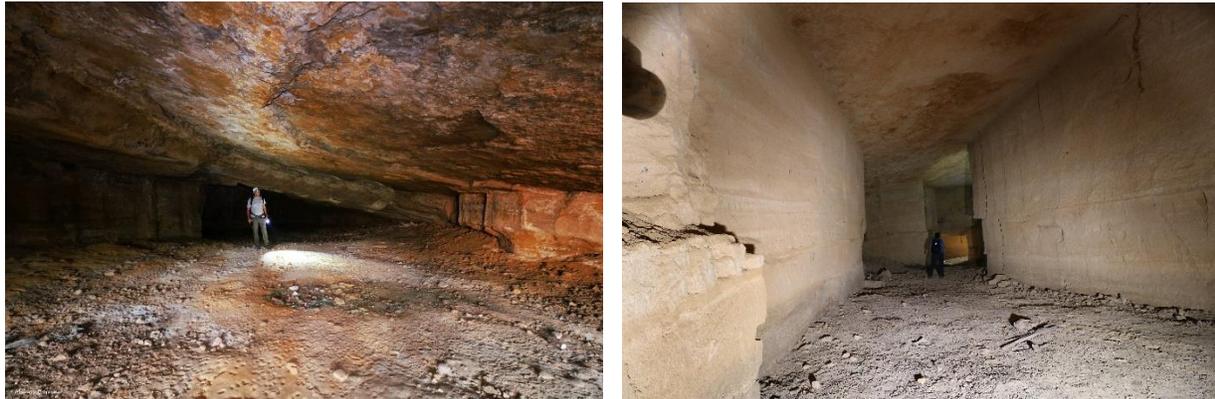
Fig. 17: Inside view of quarry landscape (cave) was developed during the exploitation of calcarenite for the production of building stone. The left one shows the landscape of a cave in Acropolis in the premises of the Headquarters of the Cyprus Telecommunications Authority (CYTA) and the right one is located in Mammari west of Nicosia.

higher and wider chambers are developed. In the cases where the quarrying chamber would become big enough, they would leave a pillar to support the overlaying layers or “roof” of the chamber approximately in the center. The underground quarries (caves), in some cases, reach a depth of 18-20 meters and in several cases amount to hundreds of square meters.

These underground caves produced by the quarrying of calcarenite were used in the past as mentioned before to host lepers, as pet stables and also as housing for poor families of homeless people of that time.

The underground quarry landscapes shown in figure 17 have not been conserved as quarry heritage. In the entrance of the cave in the Headquarters of CYTA, it has been put fill material preventing the entrance to anyone. In the case of the quarry landscape in Mammari, the area was declared as Natura 2000 due to the fact it is considered an ecological niche for bats. Unfortunately, the geological conditions of the caves were not considered during the declaration as Natura 2000. Already in the big cave in the east there was a collapse of the overlying layers and therefore daylight is entering the cave driving the bats away. The other big cave in the west as it is shown on figure 19 there are cracks on the roof and in some cases in the walls. Unless there are works to support the overlying layers, one day will collapse losing both the ecological niche for bats and the quarrying heritage.

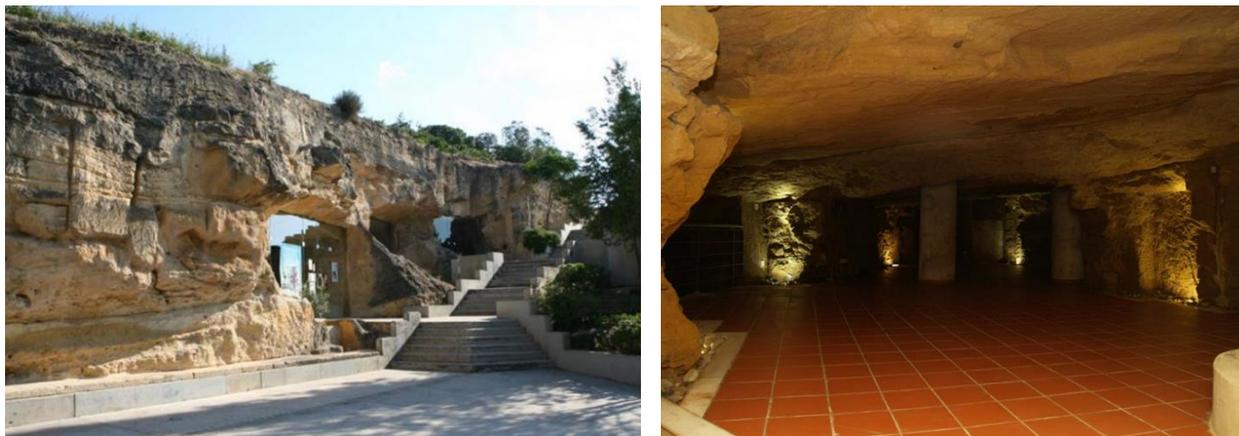
Fig. 18: On the left the external view of “skali” in Aglantzia and on the right the interior of the “Caves of Acropolis” in Strovolos.

Two of these underground quarry landscapes (caves) with the initiative of the local municipalities have been preserved. One case is “the Skali” and the other “the Caves of Acropolis” in Aglantzia and Strovolos municipalities. Both sites are used for hosting cultural events and exhibitions. At the moment part of “the Skali” is not in use due to corrective construction works performed to handle some geotechnical issues. Figure 18 on the left picture the external view of “the Skali” is shown and on the right the “Caves of Acropolis” in Strovolos.

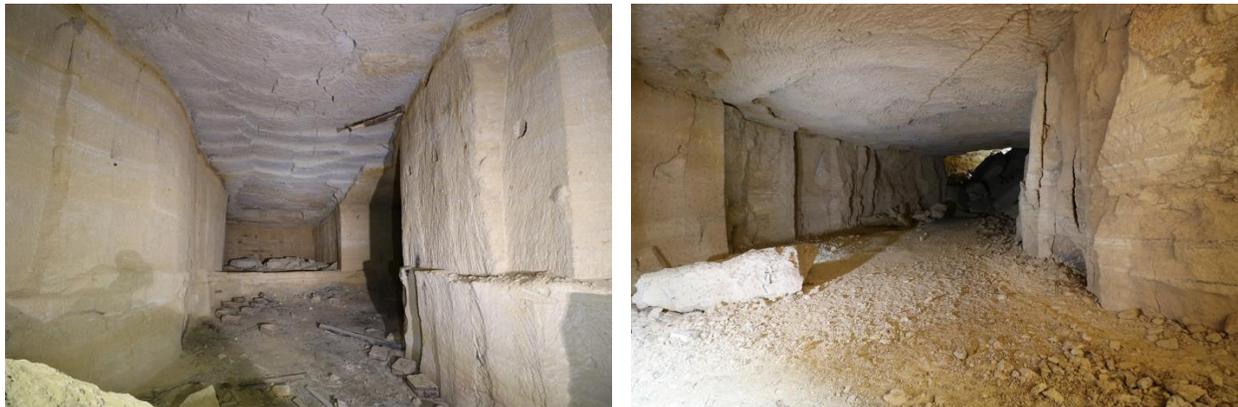
Fig. 19: Inside view of quarry landscape (cave) that shows cracks on the overlying layers and on the walls.
